# Initial Thermal Performance of a Tailings Retaining Frozen Foundation Dam, Nunavut, Canada

Christopher Stevens, John Kurylo, and Peter Luedke

Canadian Permafrost Association – Annual General Meeting  
November 16, 2020

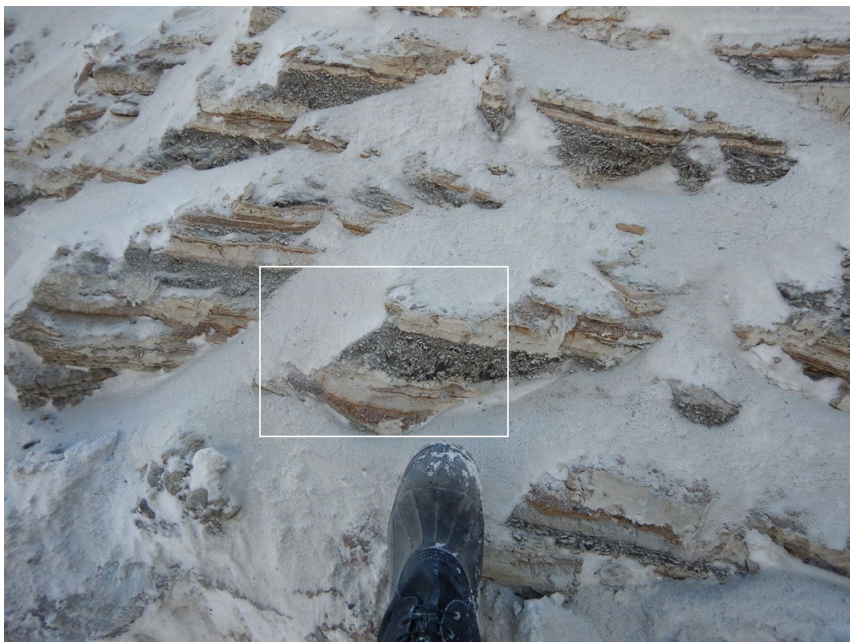
**Interbedded silt and clay**

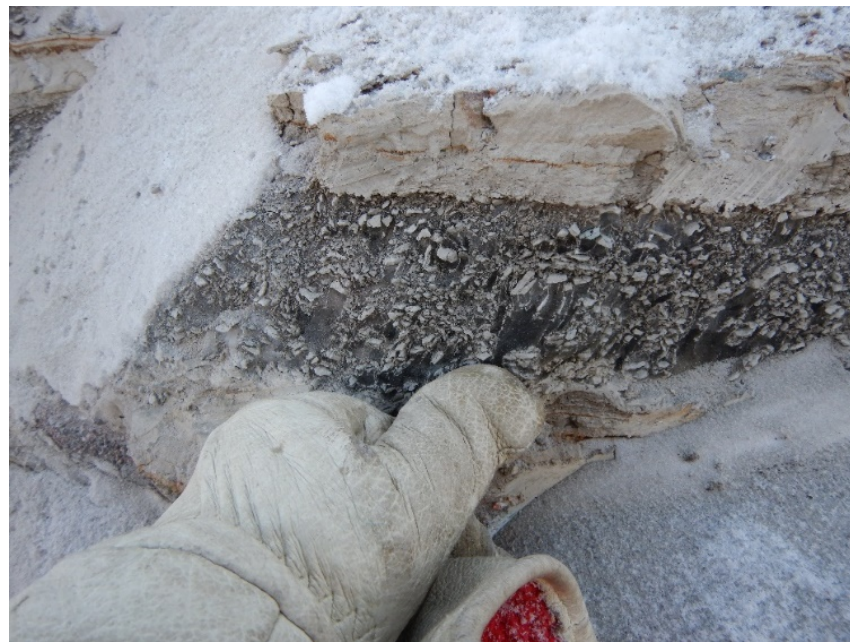
**Segregated ice lenses**

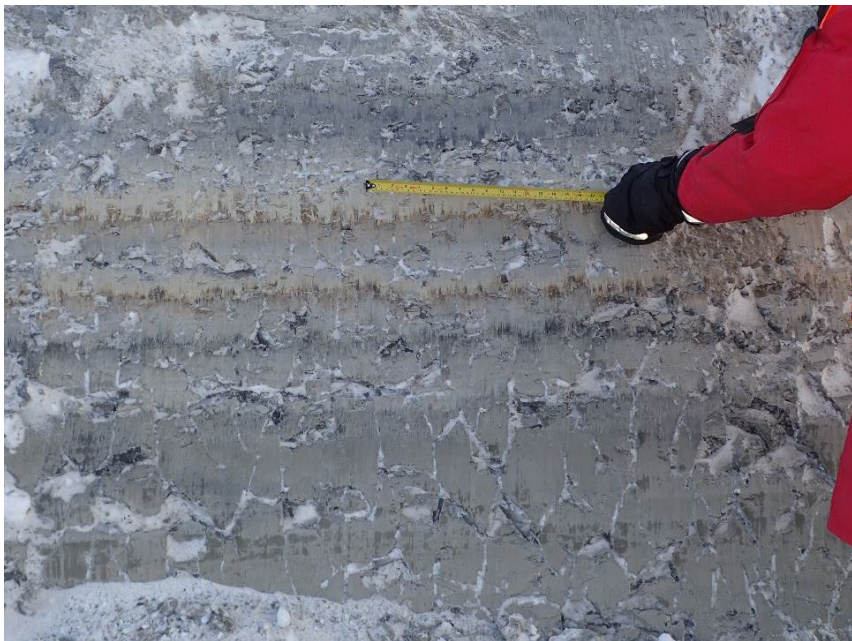
Reticulate ice

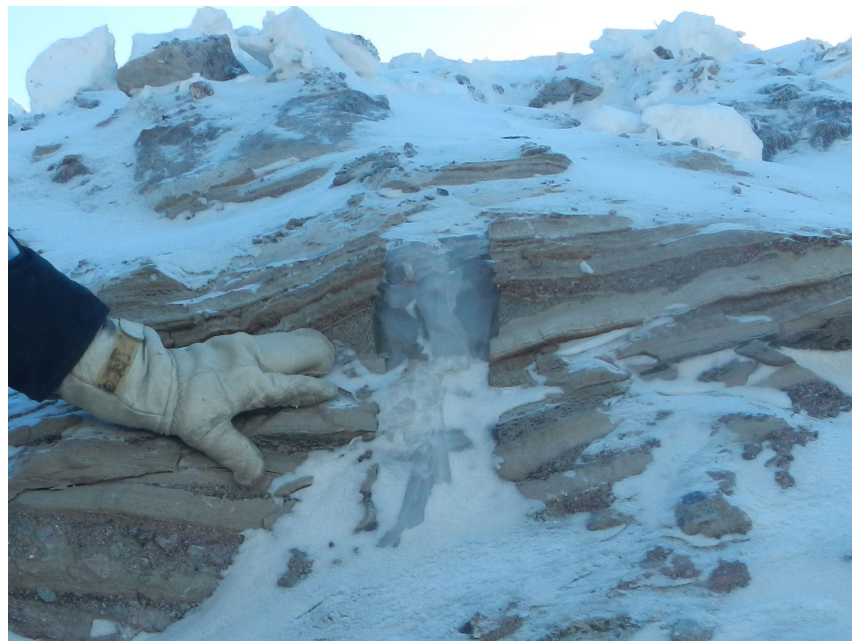
Ice Wedges

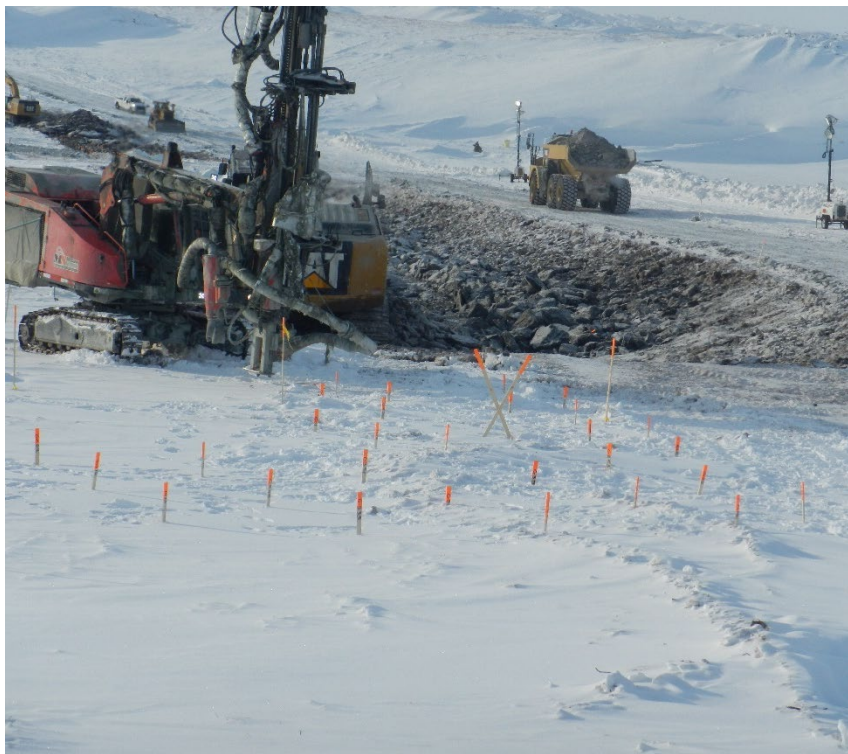
**Foreground: Drilling of blast holes**  
**Background: Key trench excavation**

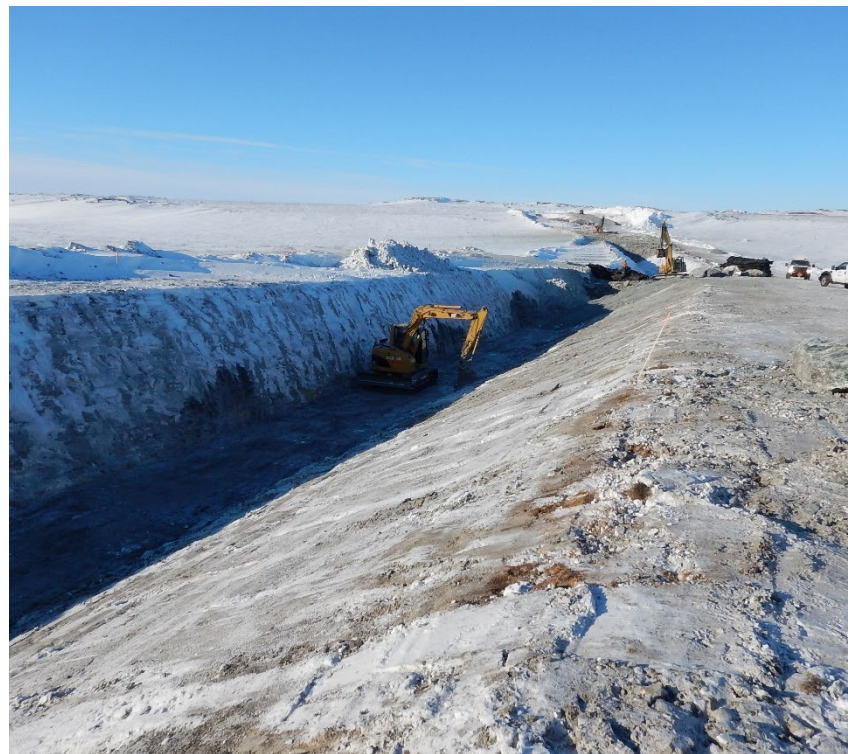
**Near complete section of key trench**

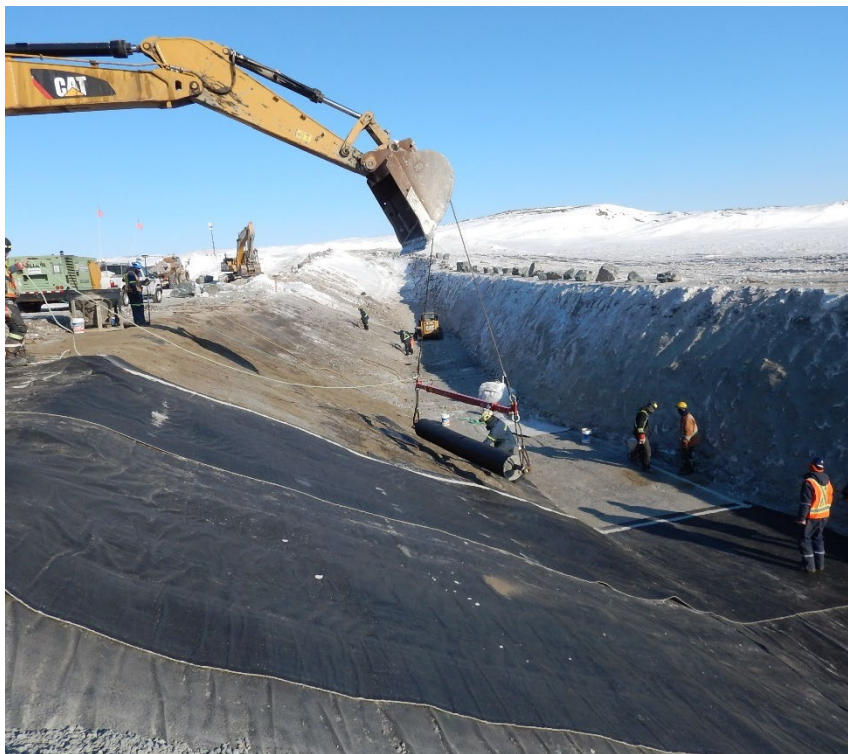
**Deployment of liner on upstream slope of key trench**

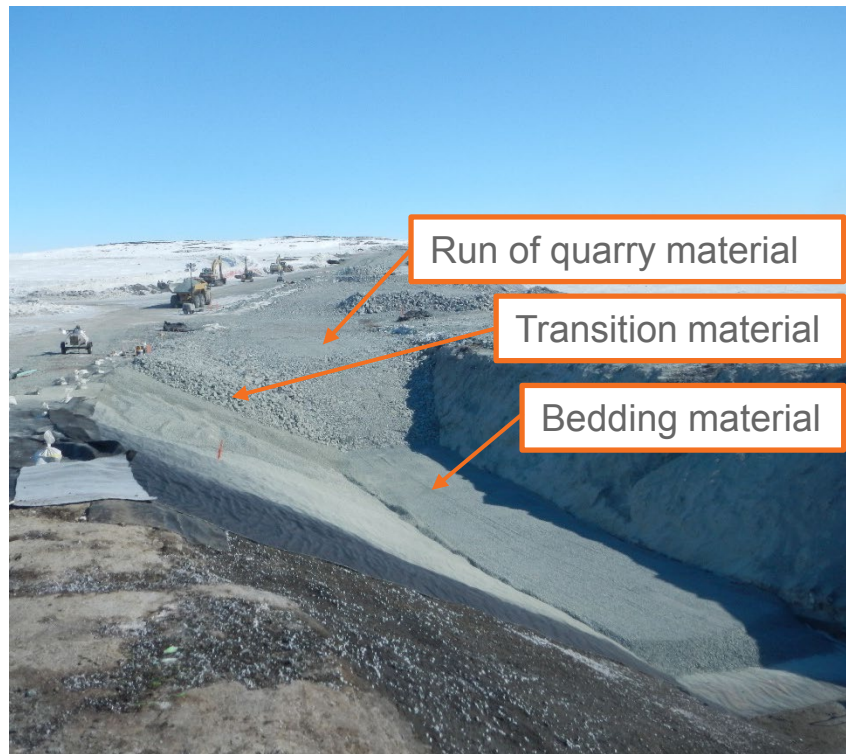
**Backfilling of key trench above liner**

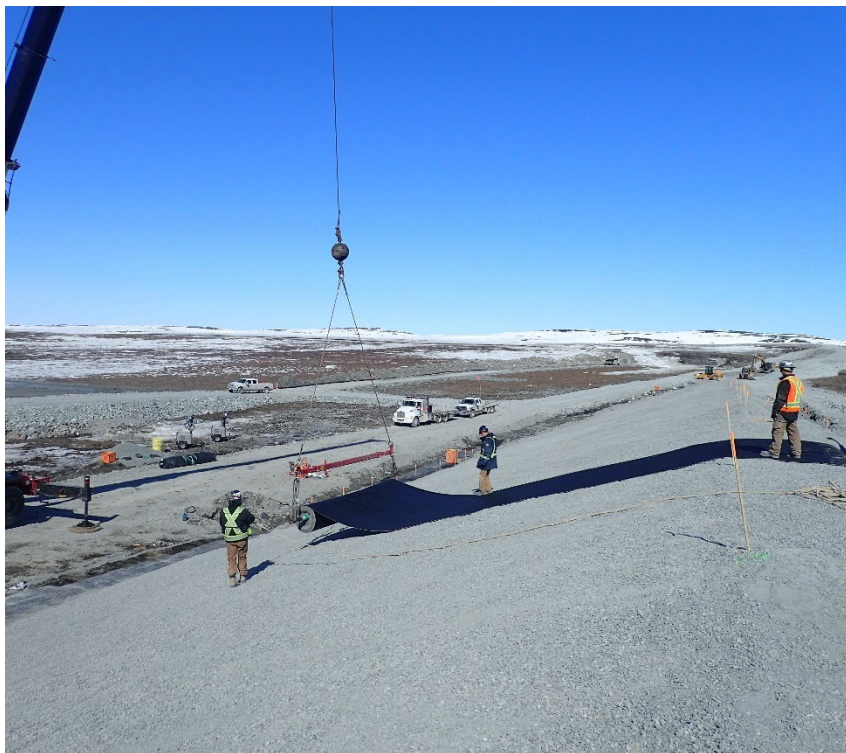
**Deployment of liner on upstream slope of above ground fill**

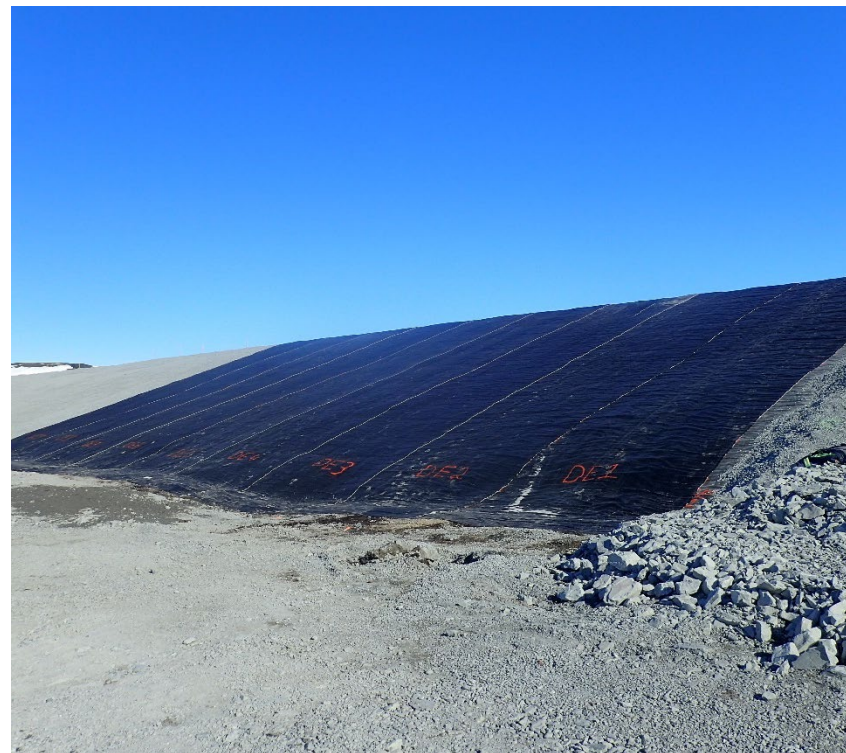
**Deployed liner on upstream slope of above ground fill**

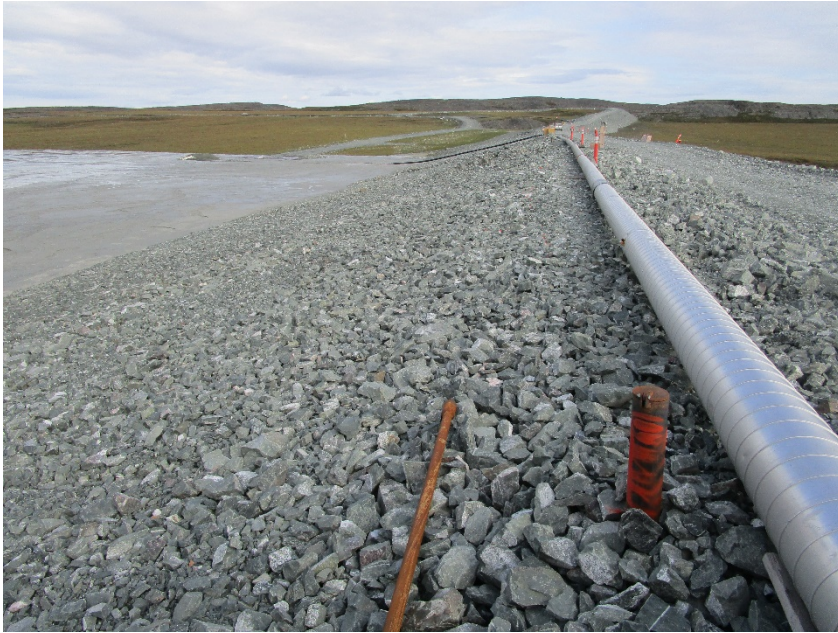
**Tailings discharge line along crest of dam**

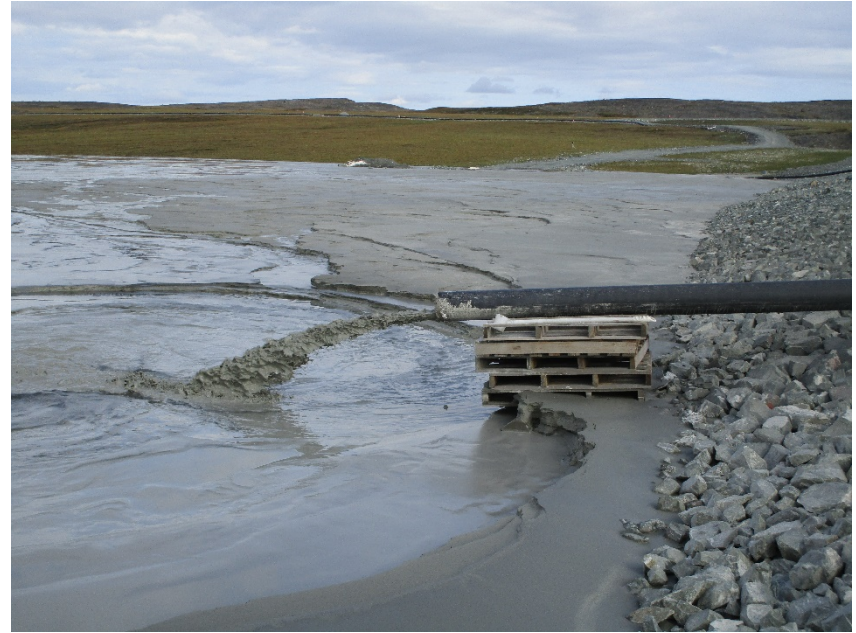
**Tailings discharge from spigot along upstream face of dam**

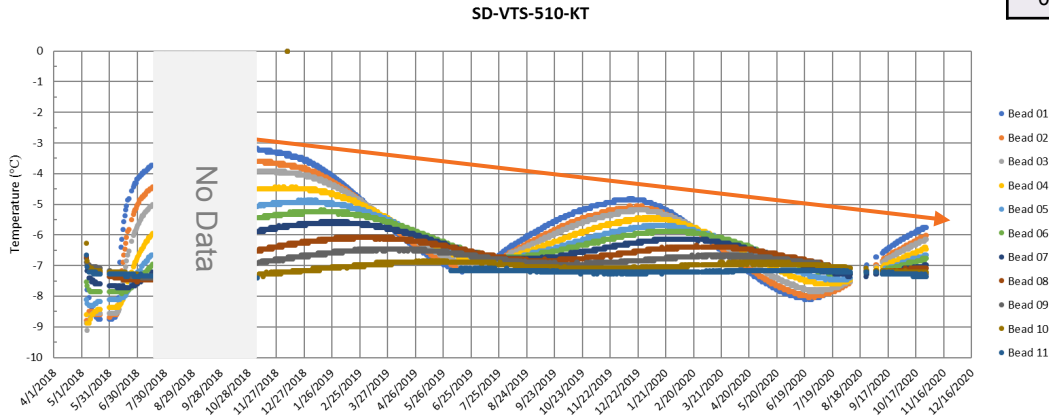
- General reduction in maximum annual key trench temperature compared to 2018
- GCL remains keyed-in to frozen permafrost (critical compliance point)
- Key trench temperatures are within the expected range of model predictions

2020 ground temperature as of Oct. 28<sup>th</sup>
