The Kiruna seismic event: important insights from the geotechnical model

Abstract

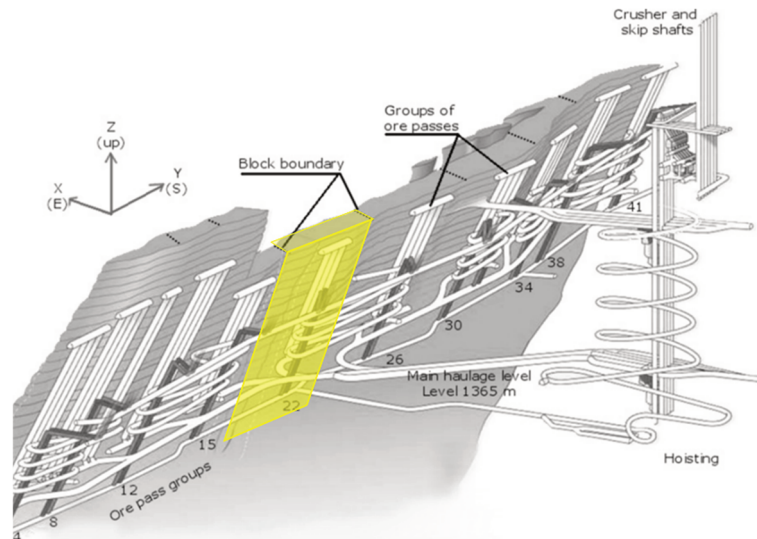
intermediate-mafic volcanic units. In addition, B22 contains late crosscutting diabase dykes, and geometrically complex bodies of dyke porphyry (DP). The hypocentre of the seismic event was interpreted to be located at or very near the intersection between the stiff DP dyke and the crush zone. A central question is to what extent do the dyke porphyries act as pillars to support the block. And another question follows, what led to the significant seismic event?

Figure 1 Sketch of the Kiruna mine orebody, with production area Block 22 of Kiirunavaara Mine highlighted. Three ore passes are located within the block. The event's hypocentre is interpreted to be located at the northern orepass

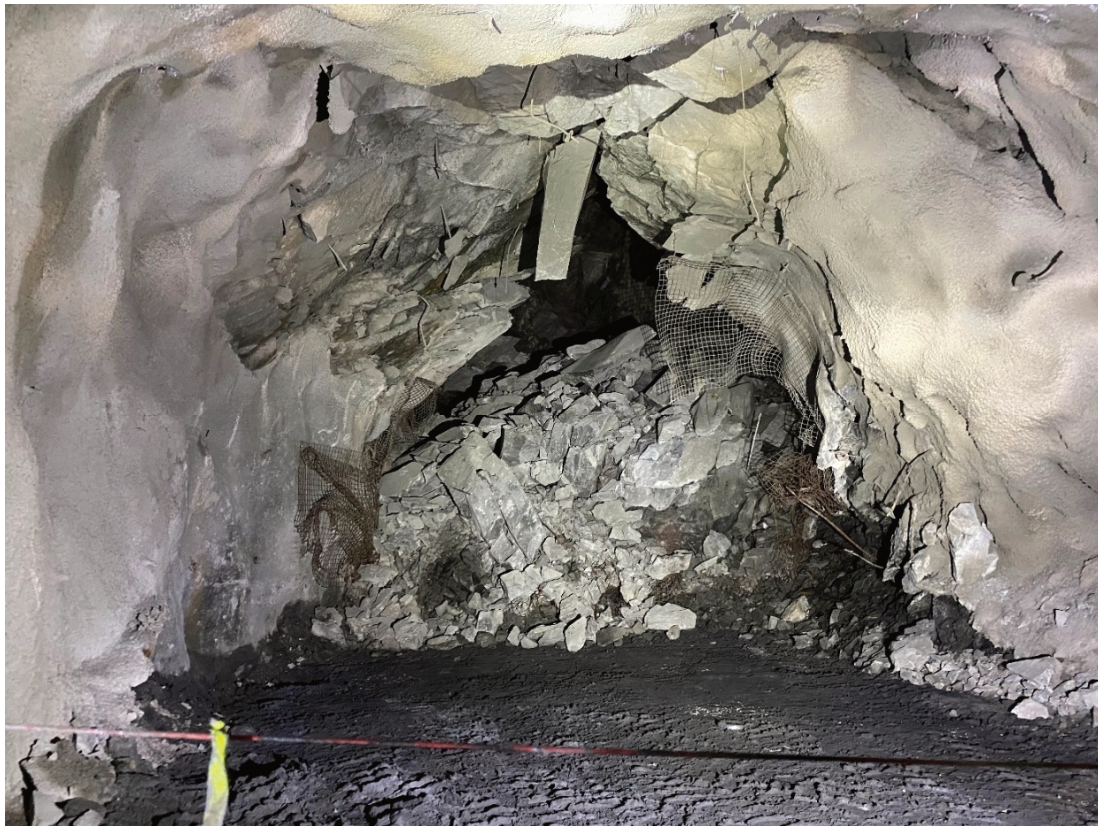
Complete failure of footwall – crosscut intersections are common on several levels. The dimensions of the fallen rock blocks clearly show (i) some blocks have been released along discontinuities to their smallest block size (Figure 2), a function of the penetrative fracture sets and veins in the rock mass, and (ii) blocks and fragments with fresh failure surfaces which has been exposed to enough high stresses to almost achieve complete fragmentation without blasting. Once fragmenting, the back continues to fail along existing fracture sets until a stable arch is achieved (Figure 2). The height of the now stable back can be more than 10 m – inaccessible to personnel – but, where, possible these voids are scanned with drones.

Figure 2 Level 1079 footwall drift looking north showing fragmentation from the back and a void above the rock pile

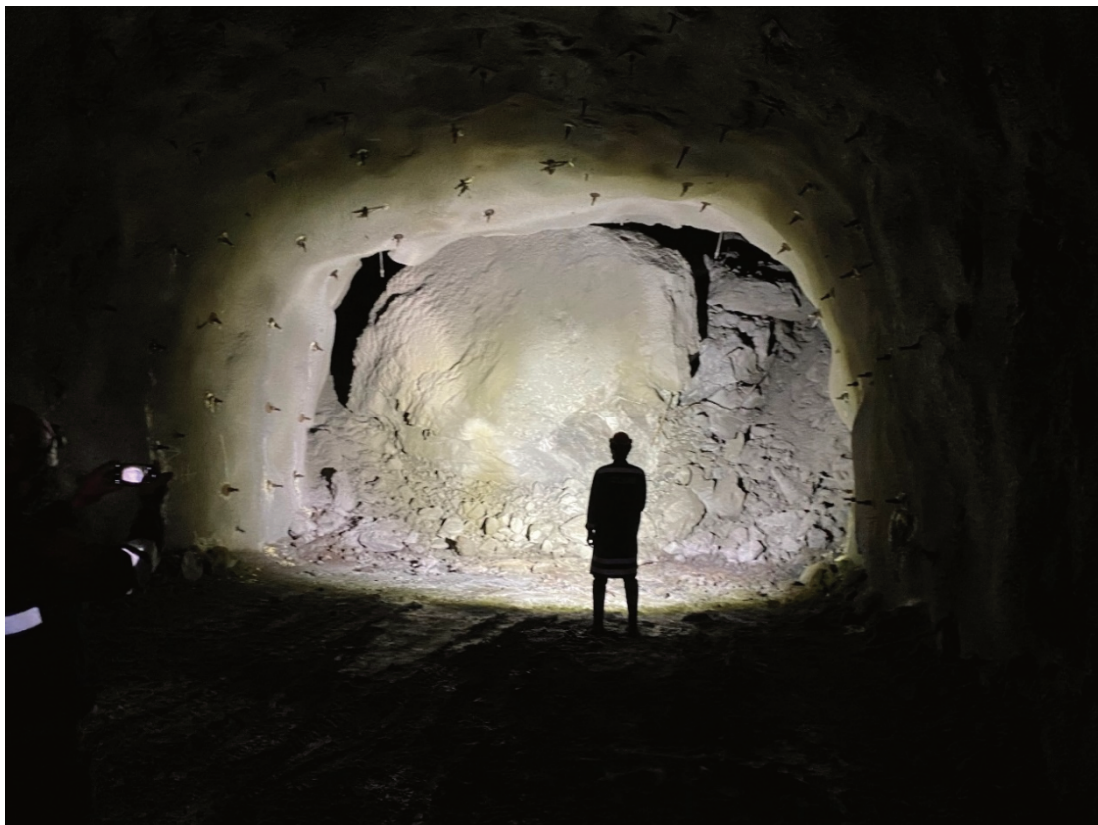
Other blocks are large enough to show unbroken, internal discontinuities (Figures 3 and 4). The block face of Figure 4 represents the ore-parallel fracture set used by the block to fail into the development. The vertical shear fractures guide the failures of some damage areas and can accommodate large vertical displacement. Utilising the vertical, ore-parallel shear fractures, large blocks drop into a development, completely sealing the crosscut tunnel (Figure 4).

Figure 3 Level 1079, Y202 crosscut looking west, fragmentation and oversized boulder

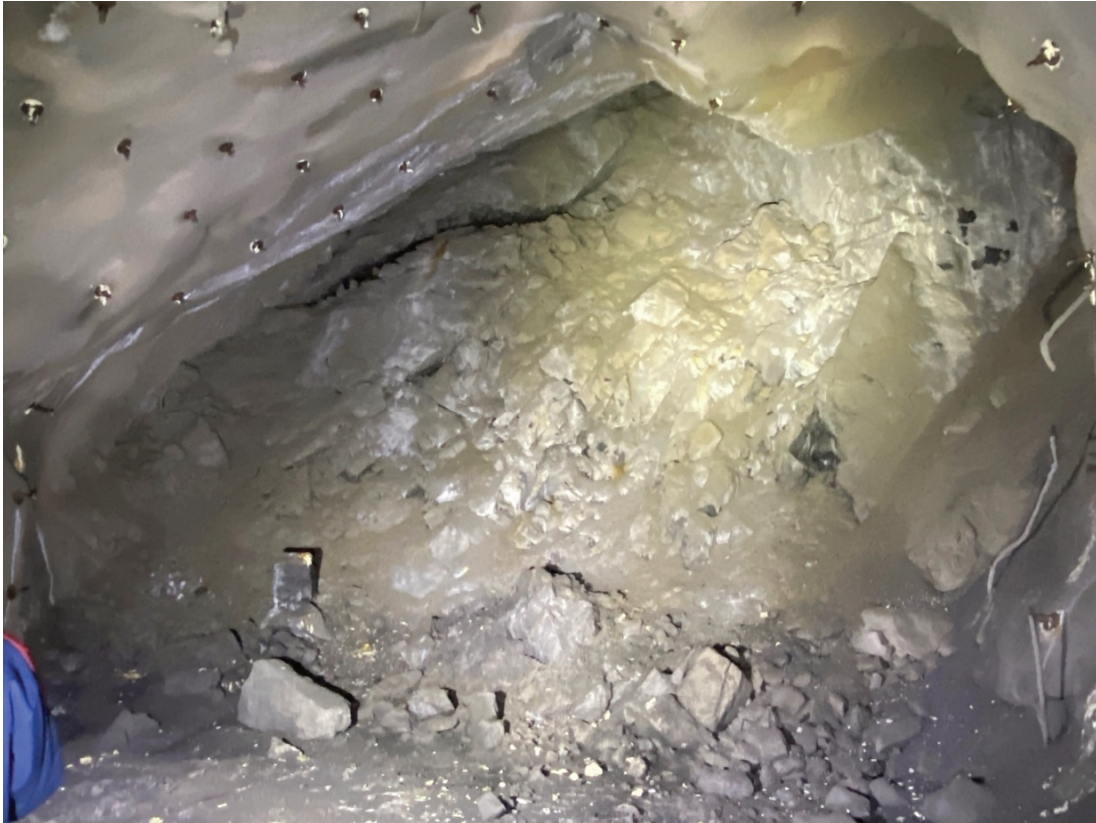
Figure 4 Level 1079 crosscut Y204 looking west, complete sealing of development

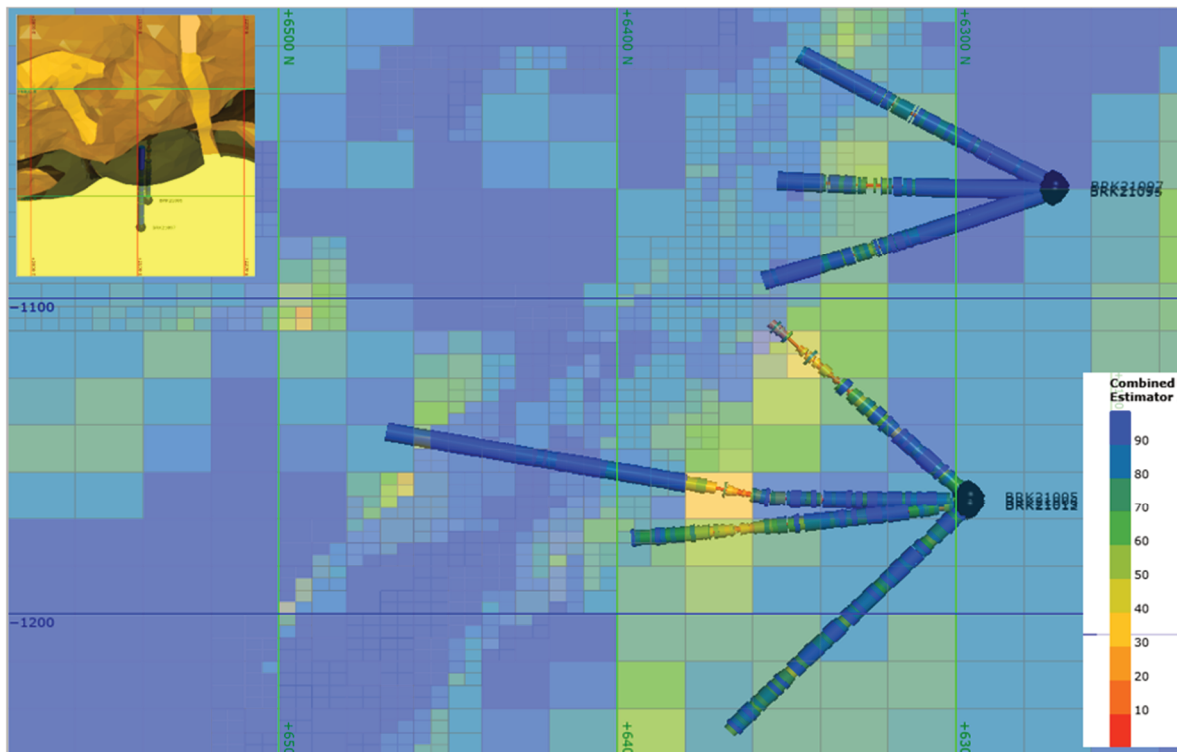
Figure 5 RQD block model cross-section of B22 at Y2100 with drill holes BRK21005, BRK21006, BRK21012, BRK21013 from lower level, and drill holes BRK21094, BRK21095, and BRK21097 from the upper level. RQD shown on drill trace and model. Inset, plan section showing drillhole positions with yellow footwall units, dark ore, and orange hanging wall units

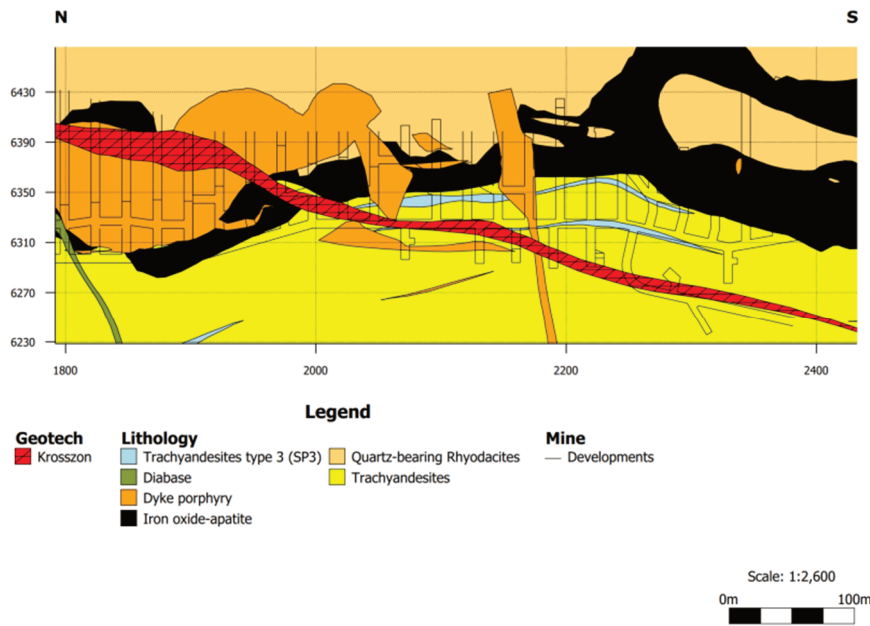
The crush zone strikes subparallel to the orebody. In the south of Block 22, it starts 100 m deep in the footwall and travels north to obliquely cut the orebody (Figure 6). At the intersect between the orebody and crush zone the orebody is heavily brecciated, and drilling shows regular core loss. Complex lithological geometries of the orebody and dyke porphyries are significant in Block 22 (Figures 6 and 7).

Figure 6 Block 22 geology at Level 1079, showing a thin orebody, country rocks, and the crush zone in red hatch

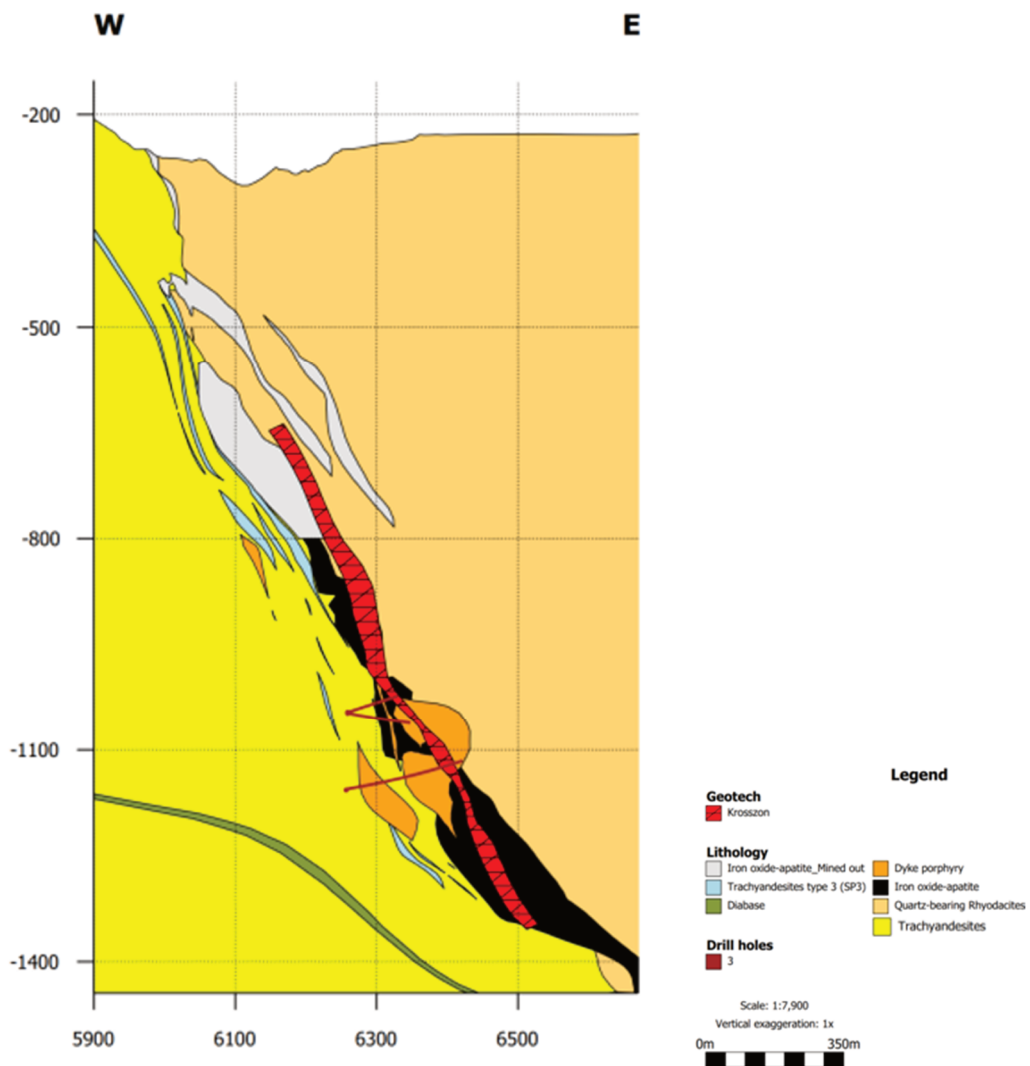
Figure 7 Vertical geological section at Block 22, Y1935, Drillhole traces in brown. Legend as in Figure 2

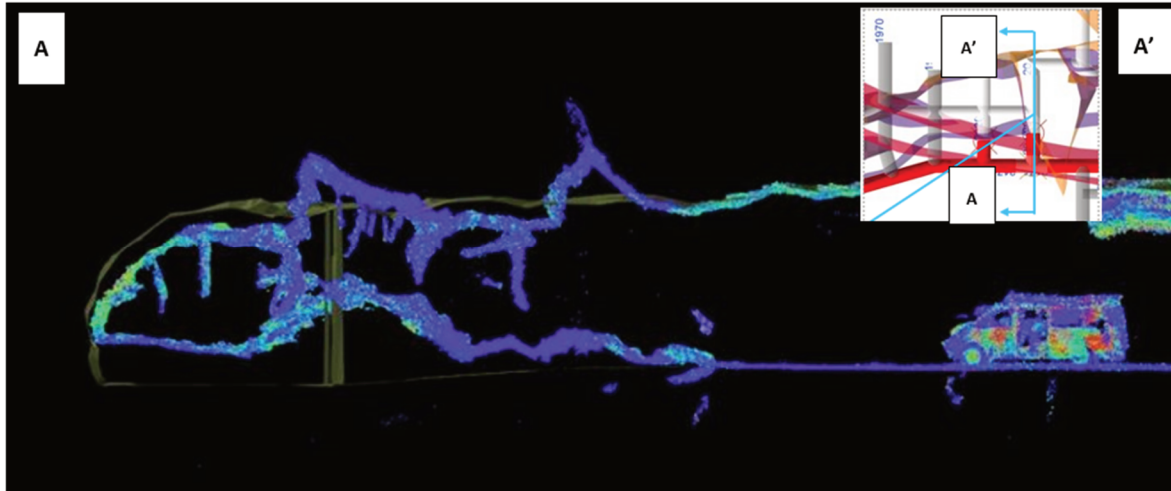
Within the crush zone, tunnel scans before and after the large event show floor heave, roof sag and overall compression (Figure 8). Reverse and normal faulting have also been documented along ore-parallel structures.

Figure 8 Level 1079, Y22 pre-event and post event scans, looking north. Blue dots, post seismic event show floor heave, roof sag and collapse of back. Scan NGM Automation, D Jatko

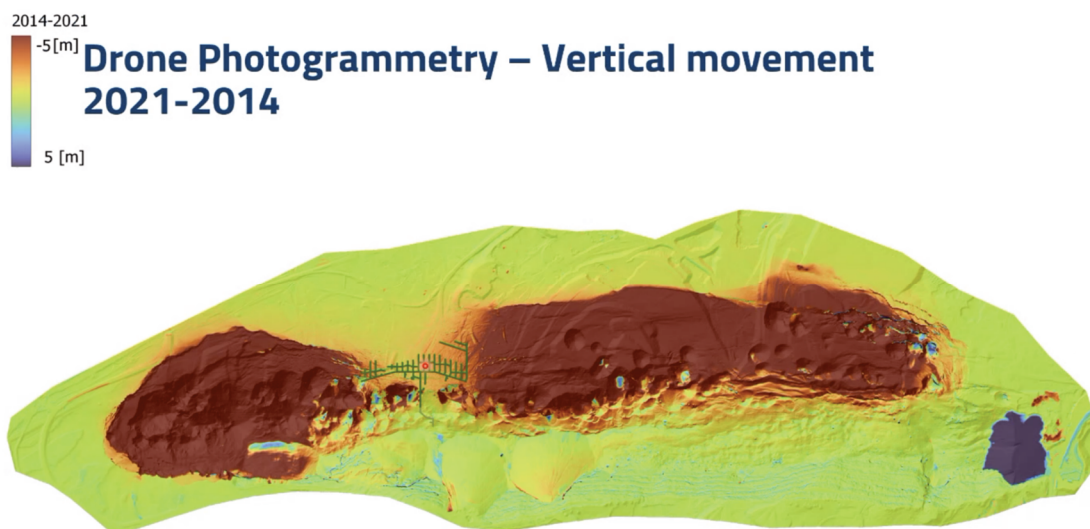
Figure 9 Surface subsidence shows the stalled cave in the Kiirunavaara hanging wall. Block 22's development position, Level -1108 m, in blue and the event hypocentre as a red dot
