The Whole Truth and Nothing but the Truth?  
A Case Study Comparing Analytical and Empirical Assessments  
Against Site Observations

**Adrienne Joaquim**

*SRK Consulting (Canada) Inc.*

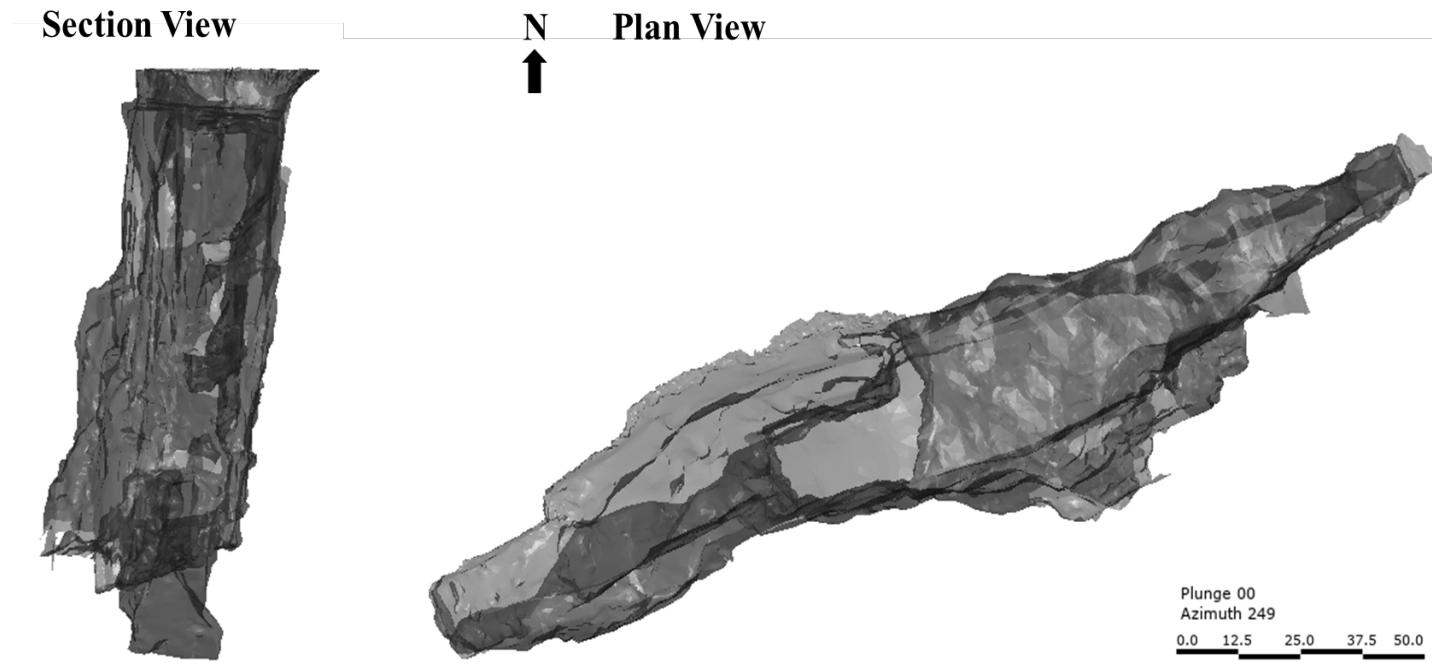
- *Available data for this site:*
  - *Collection and review of historic drawings and photographs*
  - *Review of Time Domain Reflectometry (TDR) cables installed to shallow depths in the early 1990s*
  - *A bathymetric and a 3D sonar survey of the pond and the connected flooded workings*
