Initial Performance of Sloped Thermosyphons for Stabilization of Massive Ground Ice

Christopher Stevens, PhD SRK Consulting Inc.

Dry Creek Highway Test Section

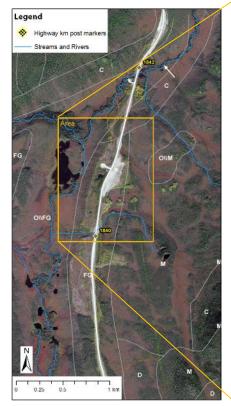
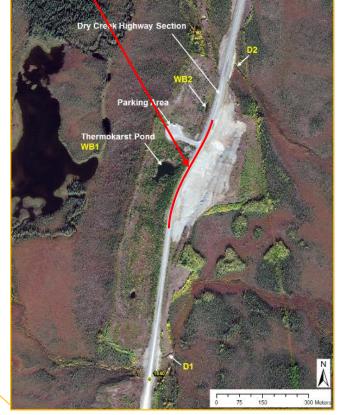
- General stratigraphy
 - Sand and gravel, underlain by silt
 - Massive ground ice > 9 m thick
- Warm permafrost (>-1.0°C) within ROW
- Beneath embankment >-0.5°C with sideslope suprapermafrost talik
